BST Graphs of Long Term Monitoring Results for B1C

Graph Narrative

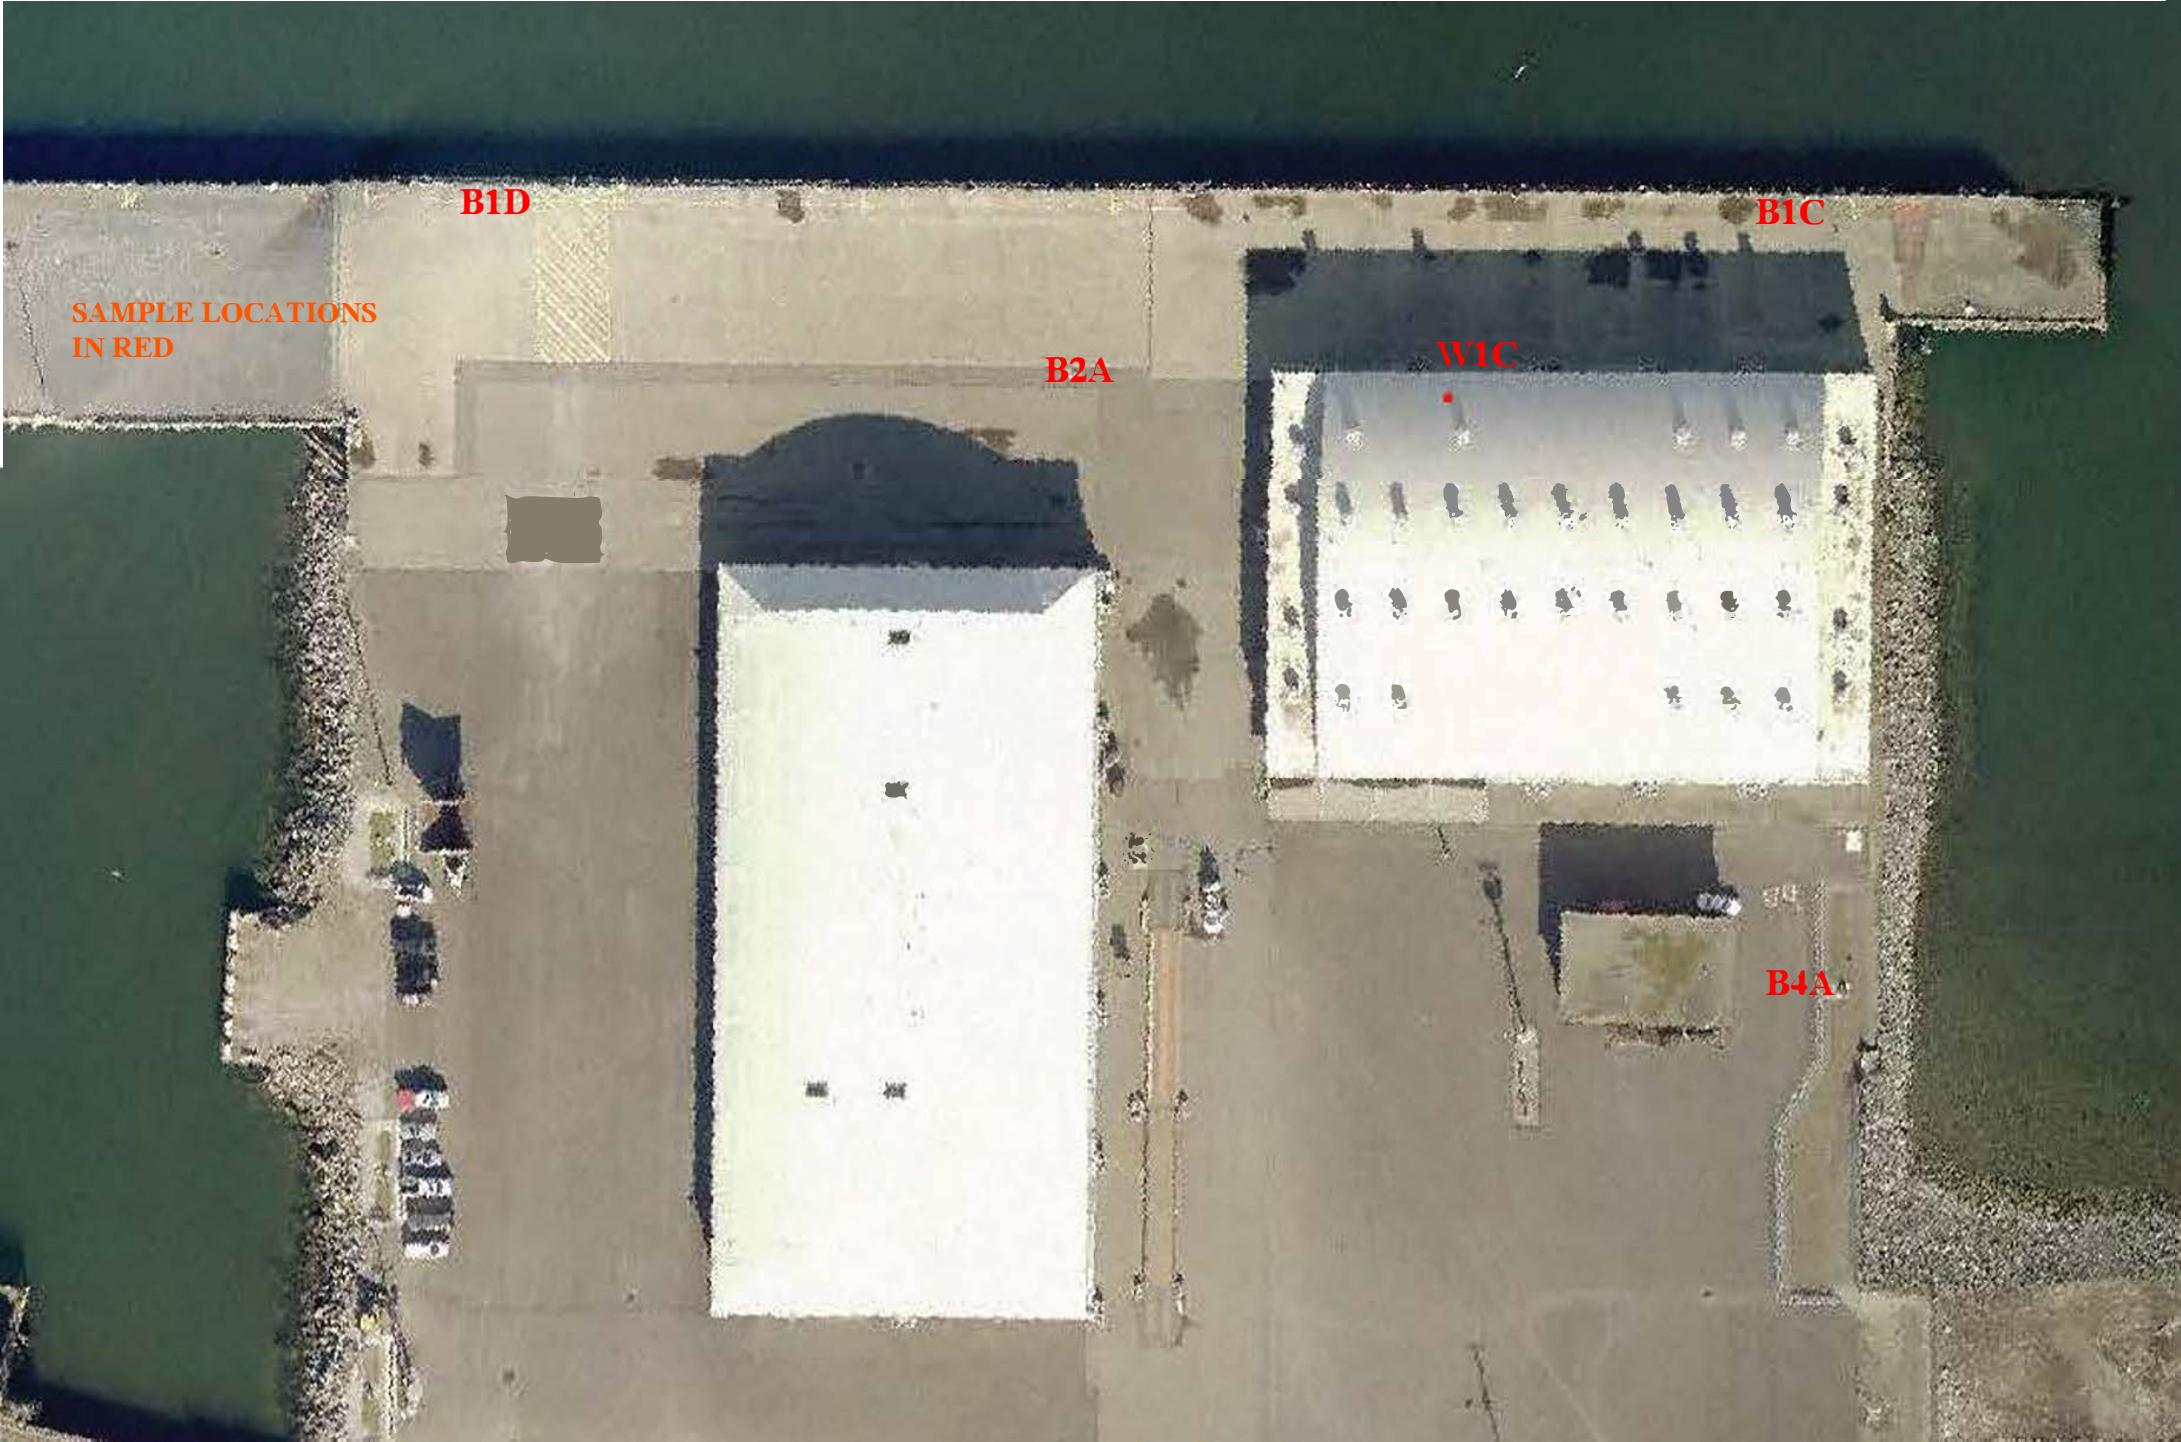
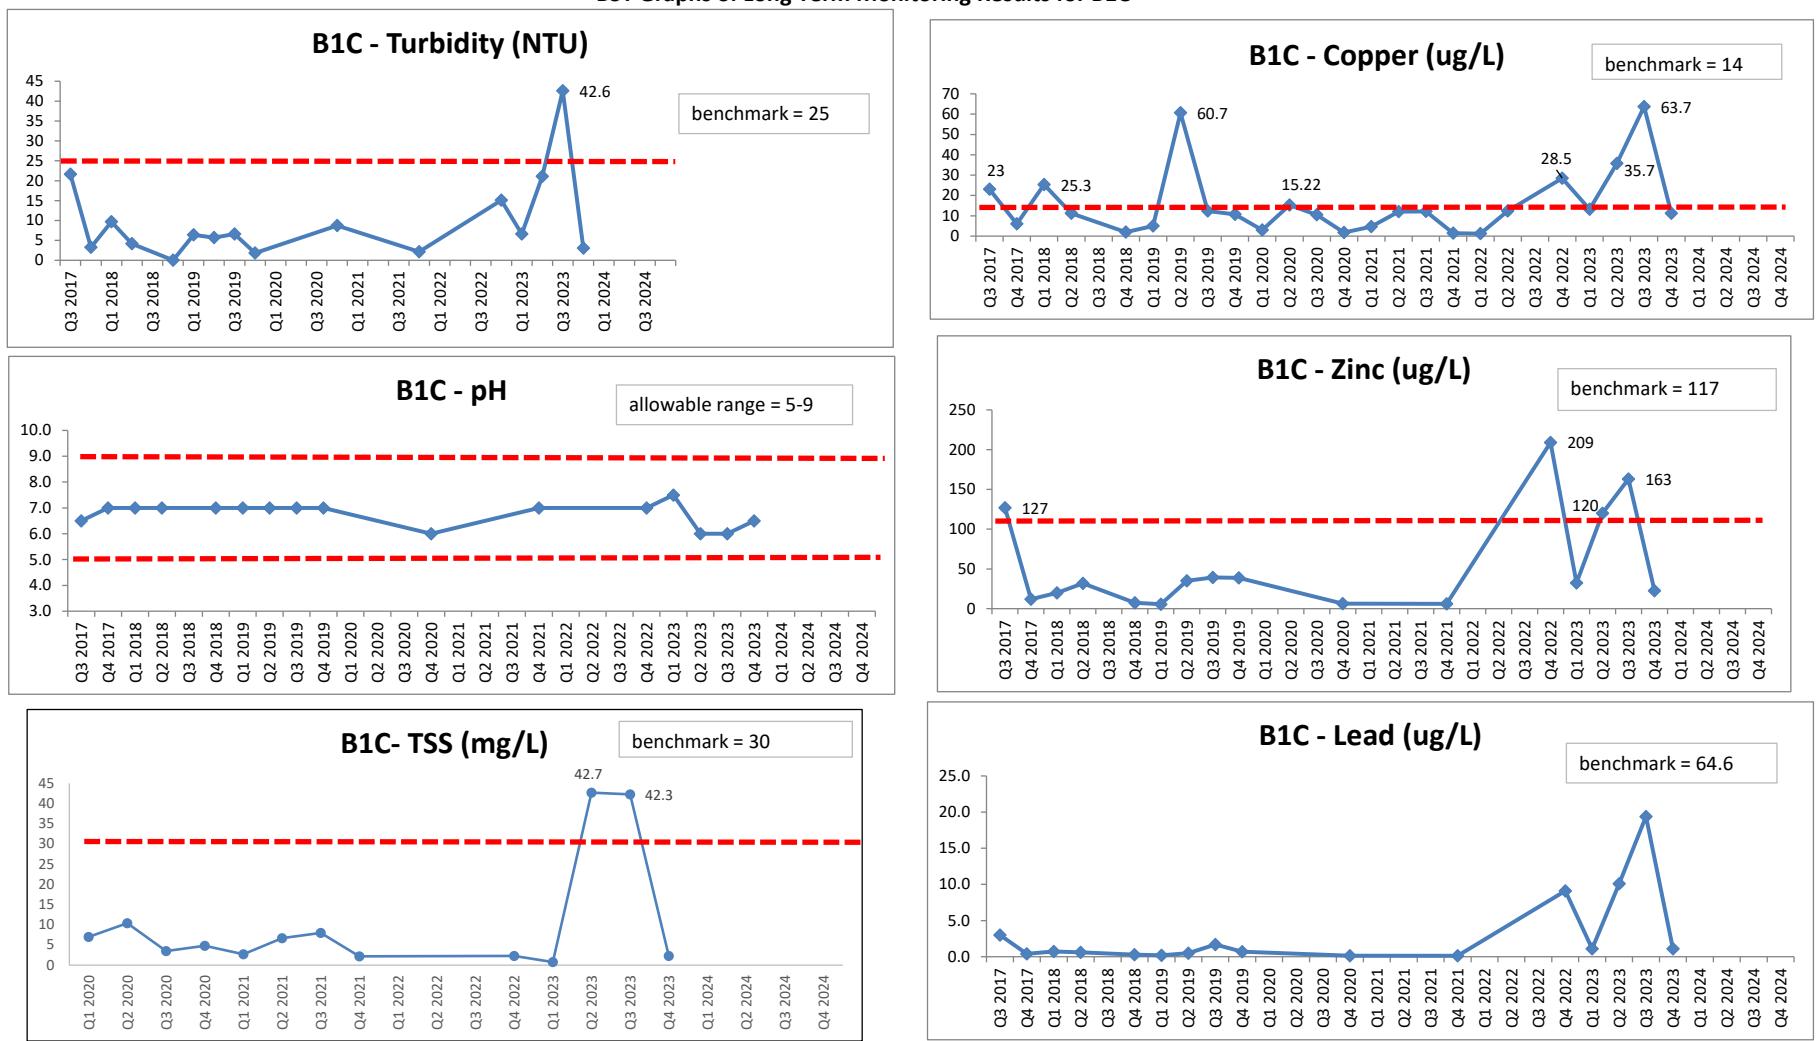
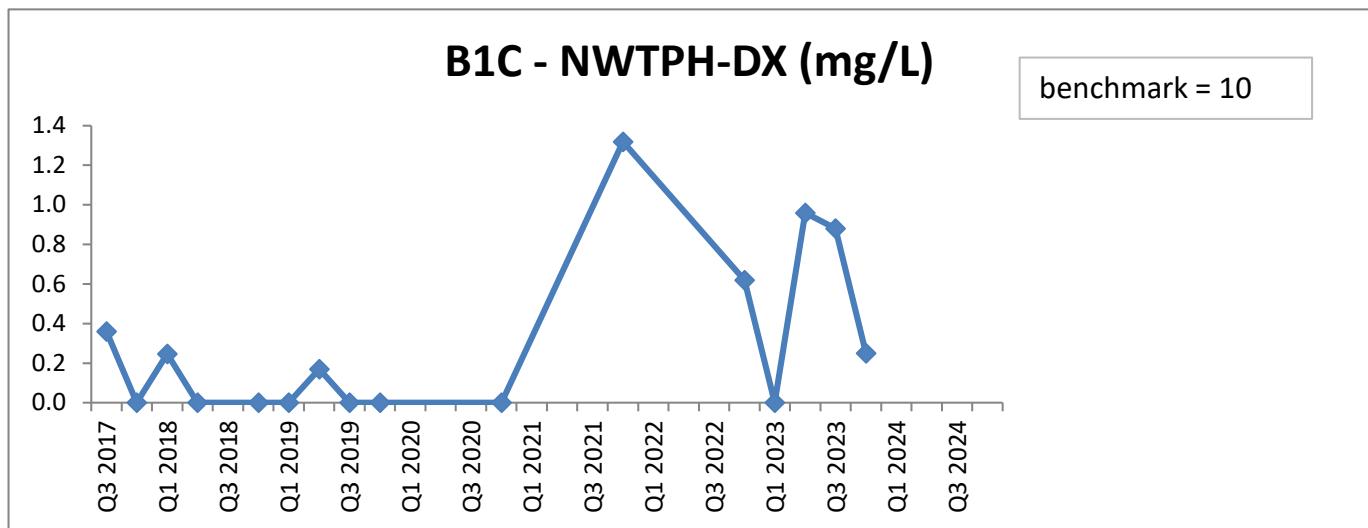
B1C = Stormwater sheet flow discharge from the north pier.

- The graphs represent 5 of the 6 sampling locations at the Bellingham Shipping Terminal from the beginning of Port ISGP coverage in Q3 2017 until the present.
- Permit sample benchmarks are denoted by the red dotted lines in the graph. The pH benchmark has an allowable range of pH 5 to pH 9. For parameters where stormwater results are far below the permit benchmarks, the red benchmark line is not included due to the scale of the graph, but the benchmark value is listed in a text box.
- For quarters showing no data point, this is either due to no sampling because there was no discharge, or because the parameter was in “Consistent Attainment” a no-sampling status which is earned after 8 consecutive quarters of meeting permit benchmarks.

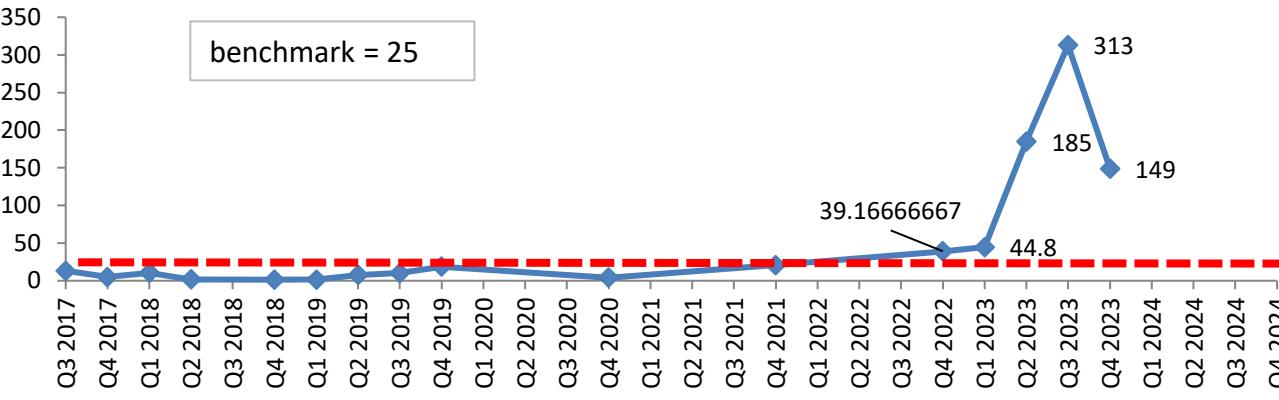
B1D- Turbidity (NTU)

B1D = Treated discharge from stormwater sheet flow in the middle wharf loading area. Treatment is Wharf Treatment Unit (WTU, media filtration).

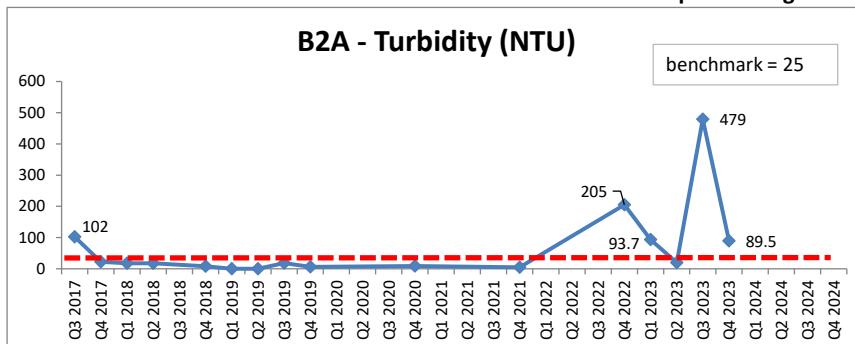
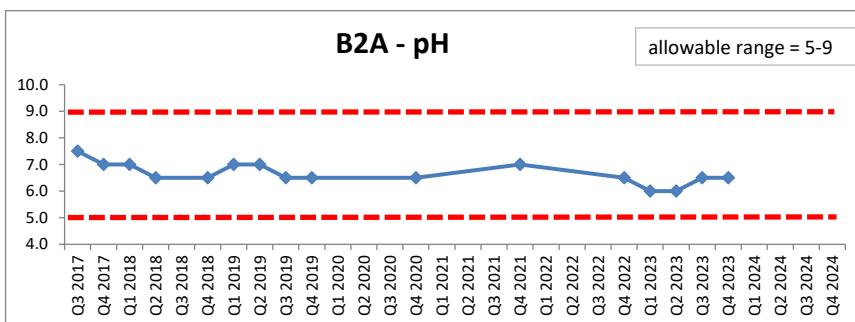
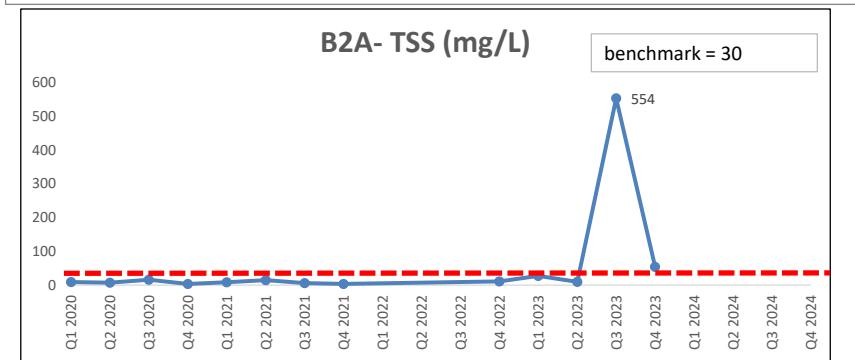
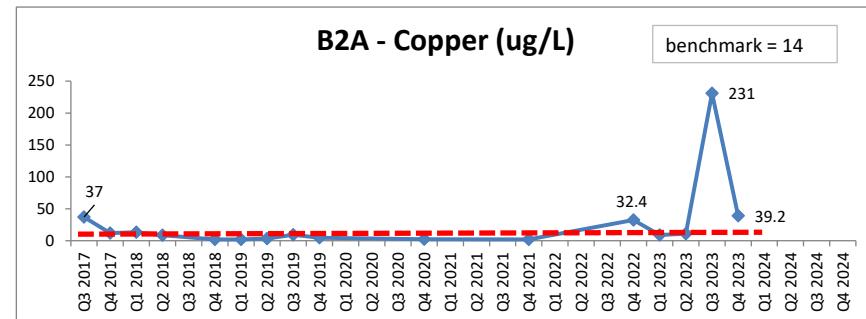
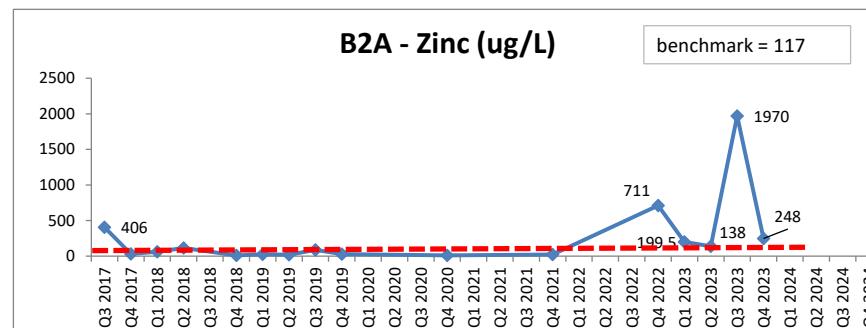
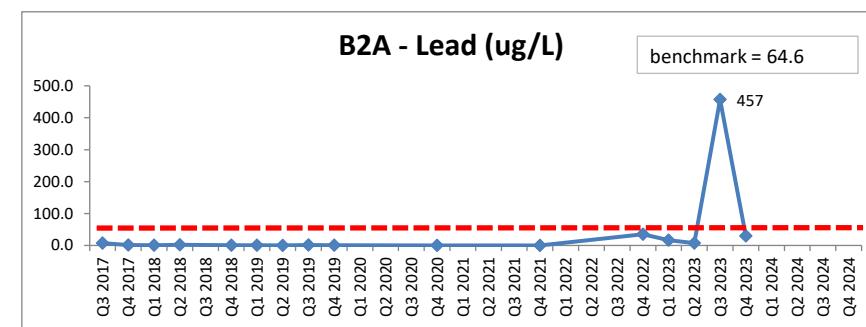
BST Graphs of Long Term Monitoring Results for B2A

B2A = Catch basin between Warehouse 1 and Warehouse 2.

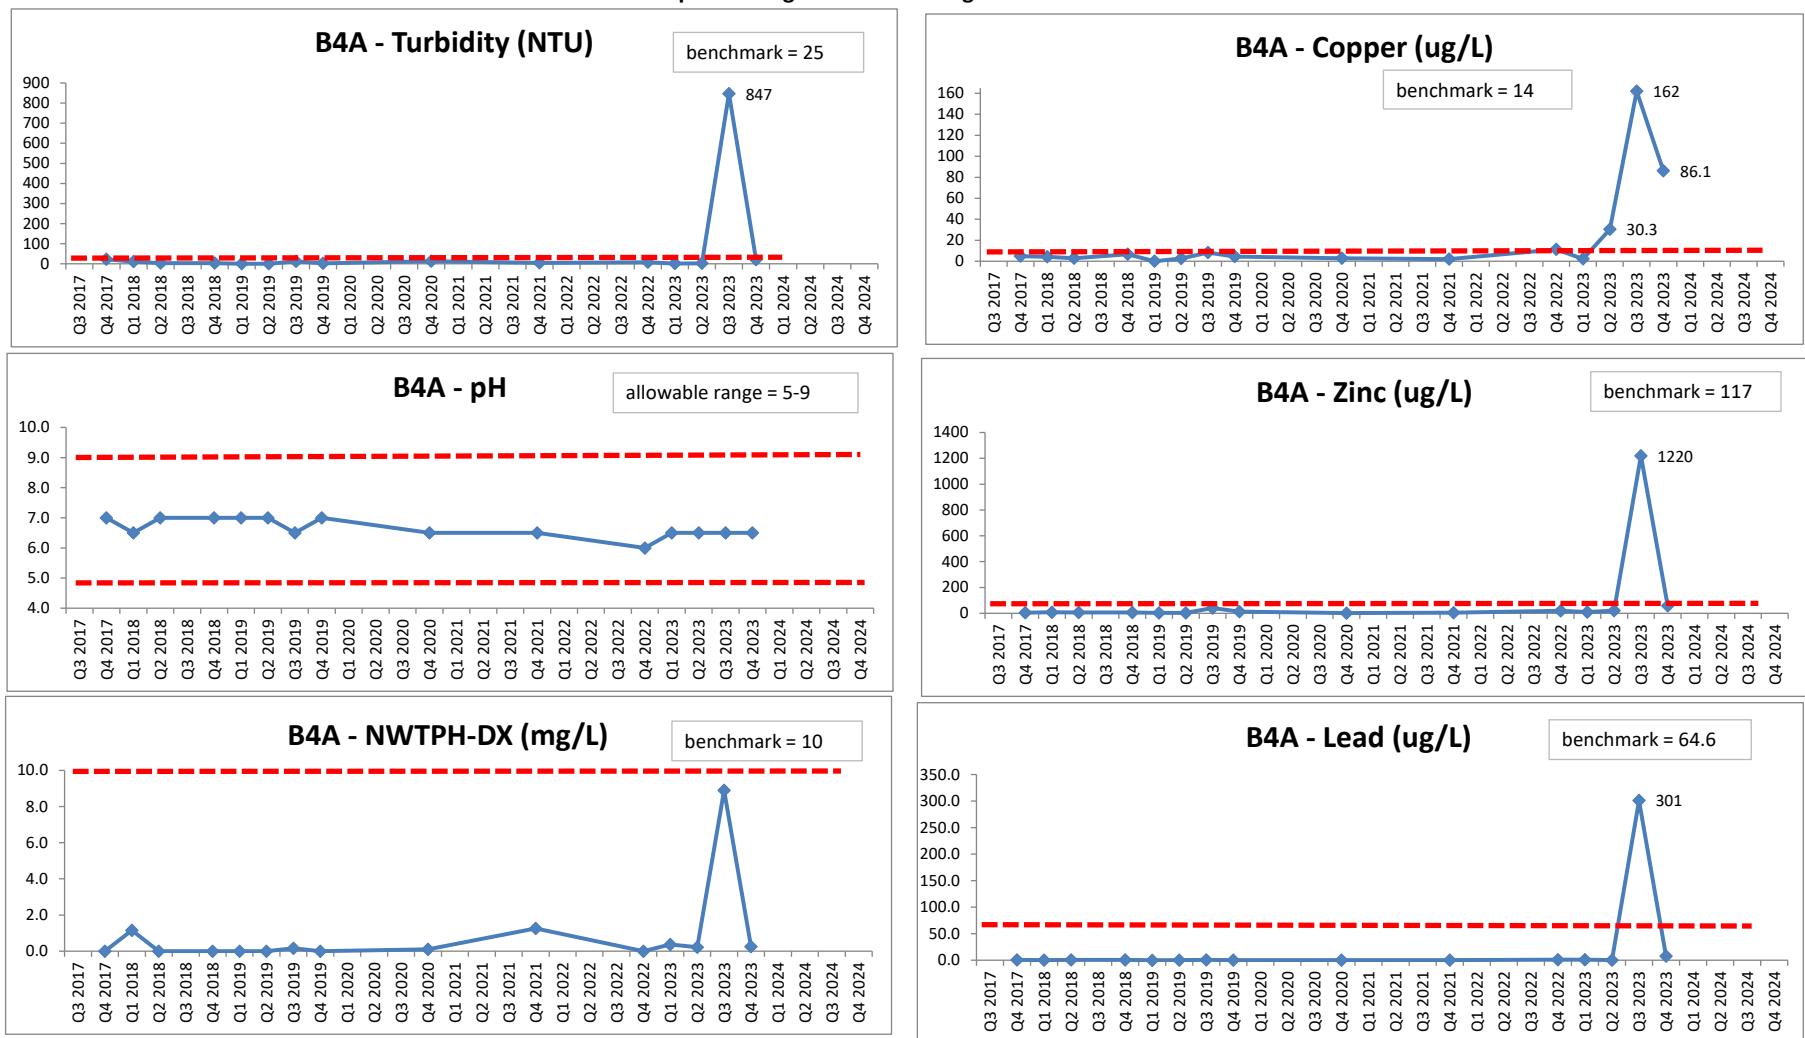
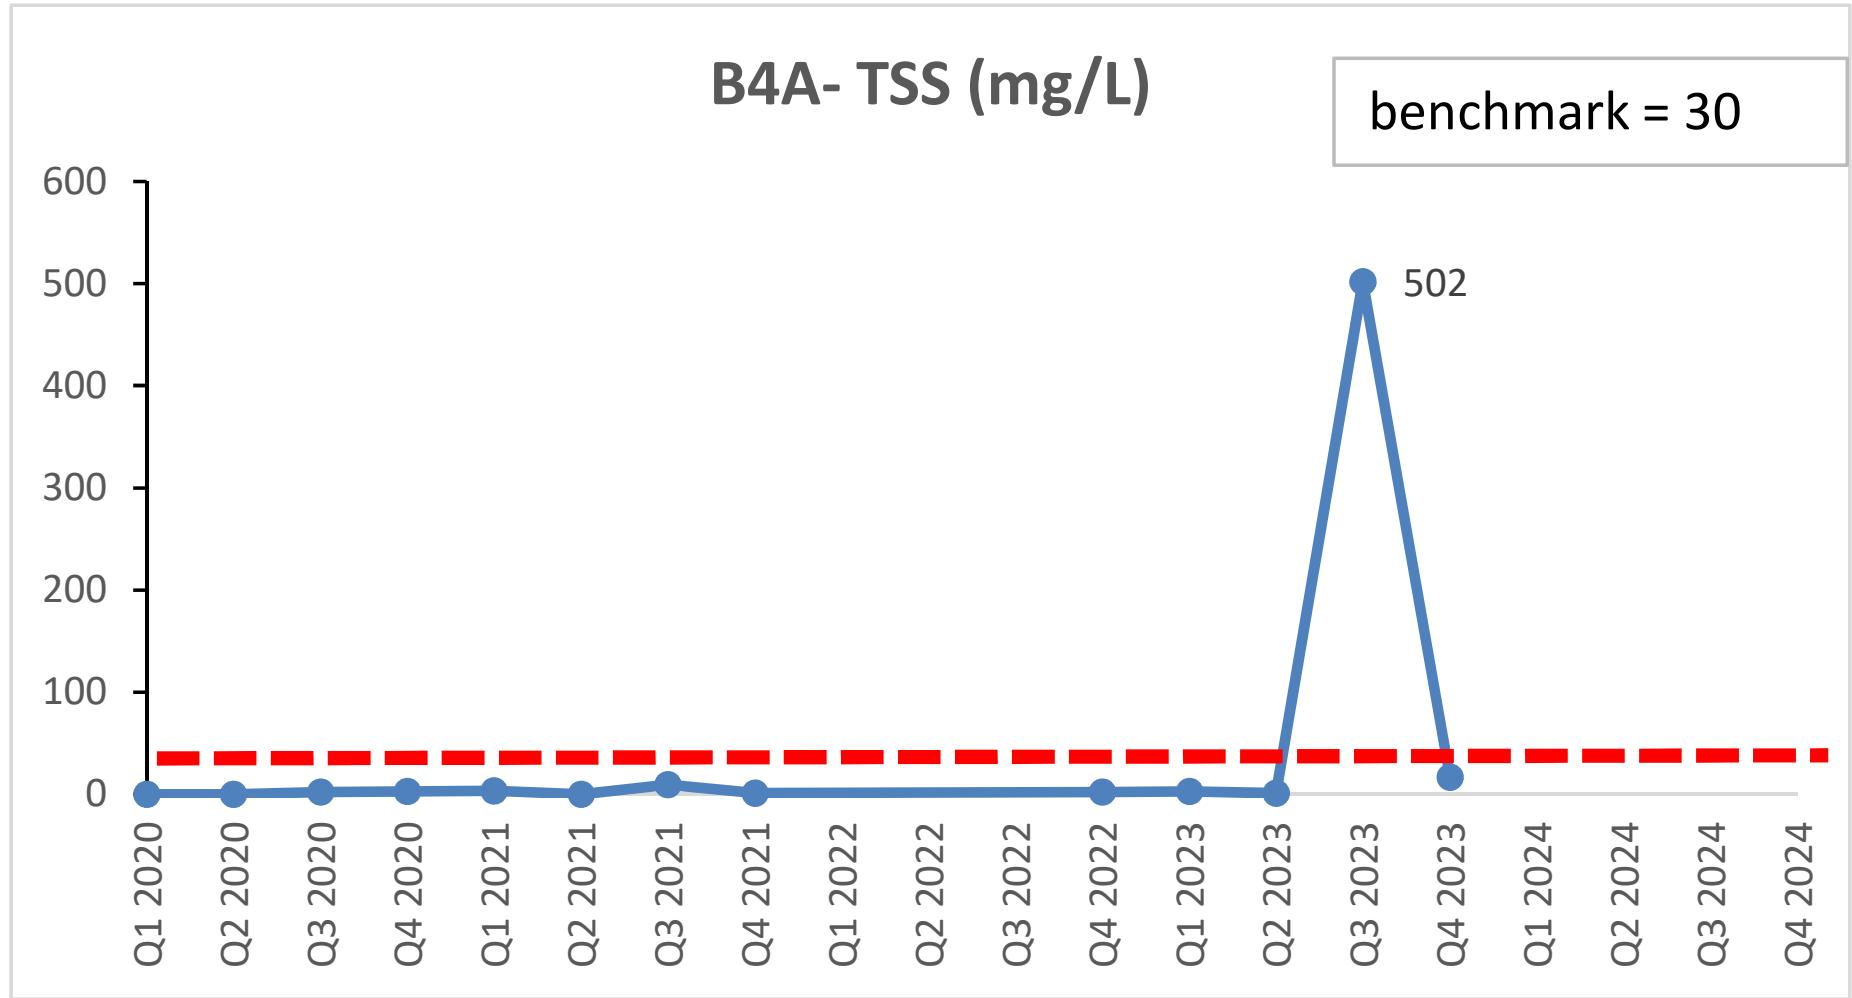
BST Graphs of Long Term Monitoring Results for B4A

B4A = Treated stormwater from Basin 4. Treatment is media filter drain (MFD)

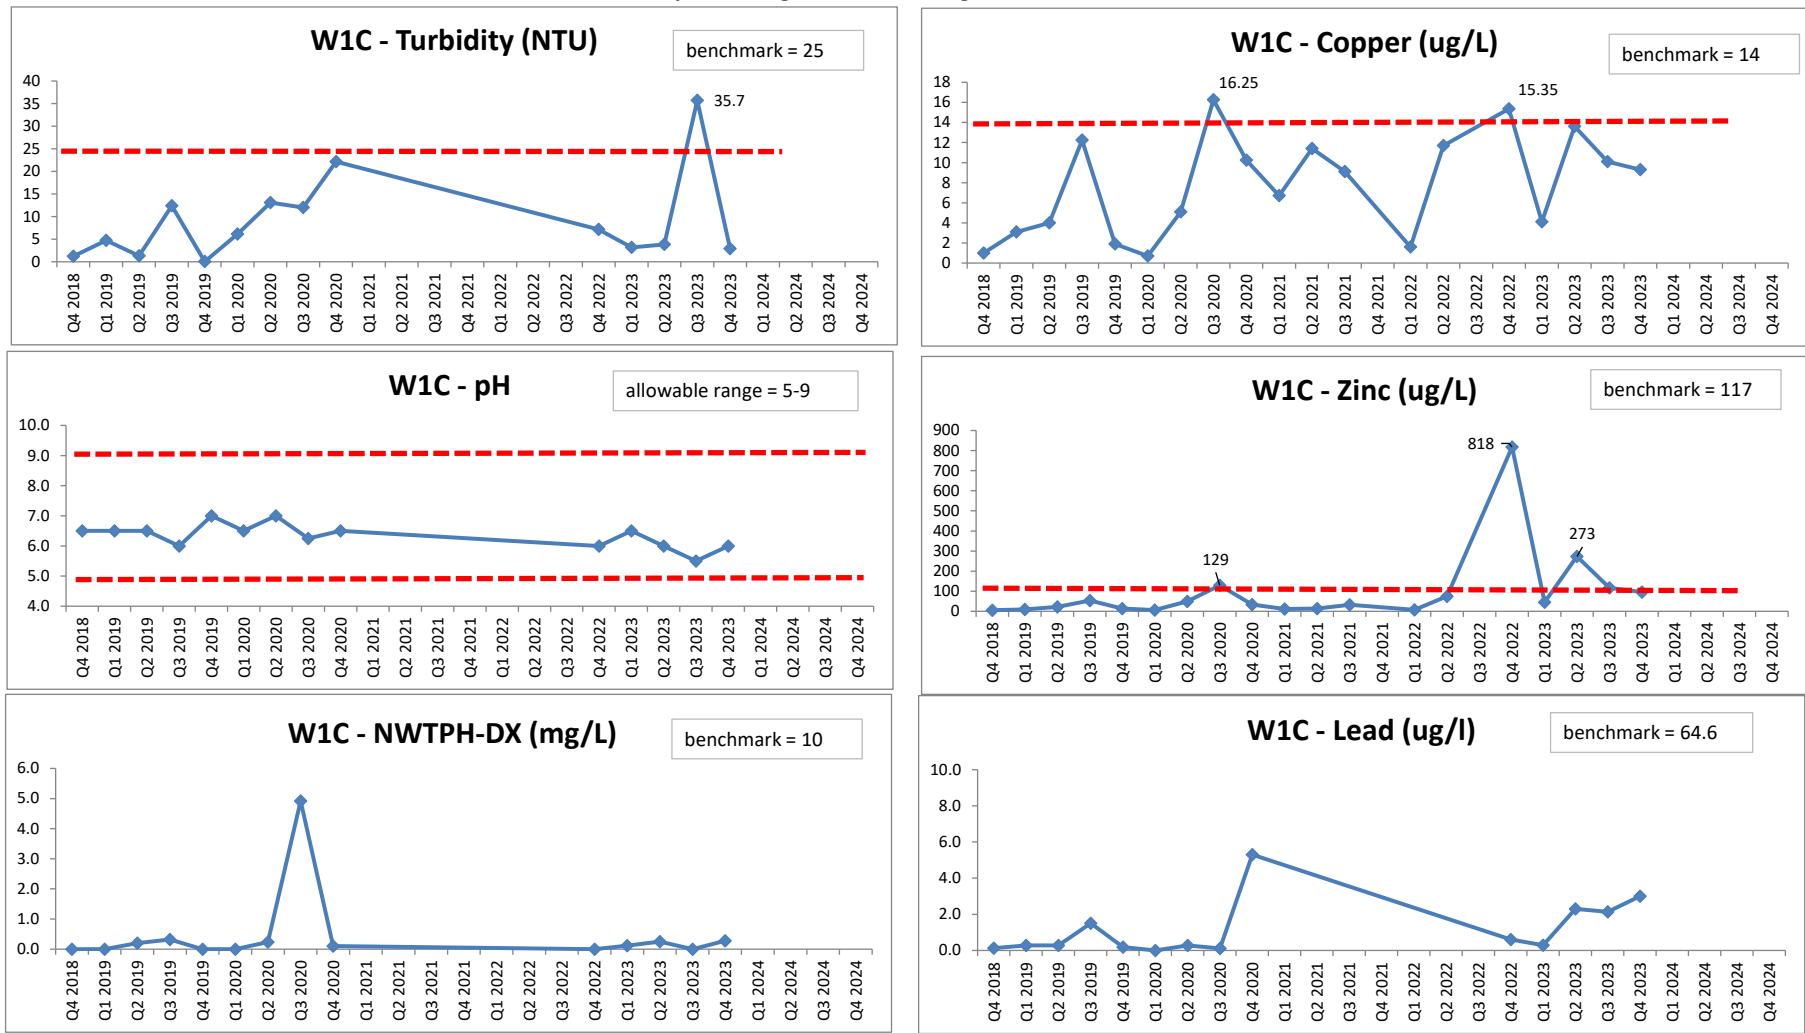
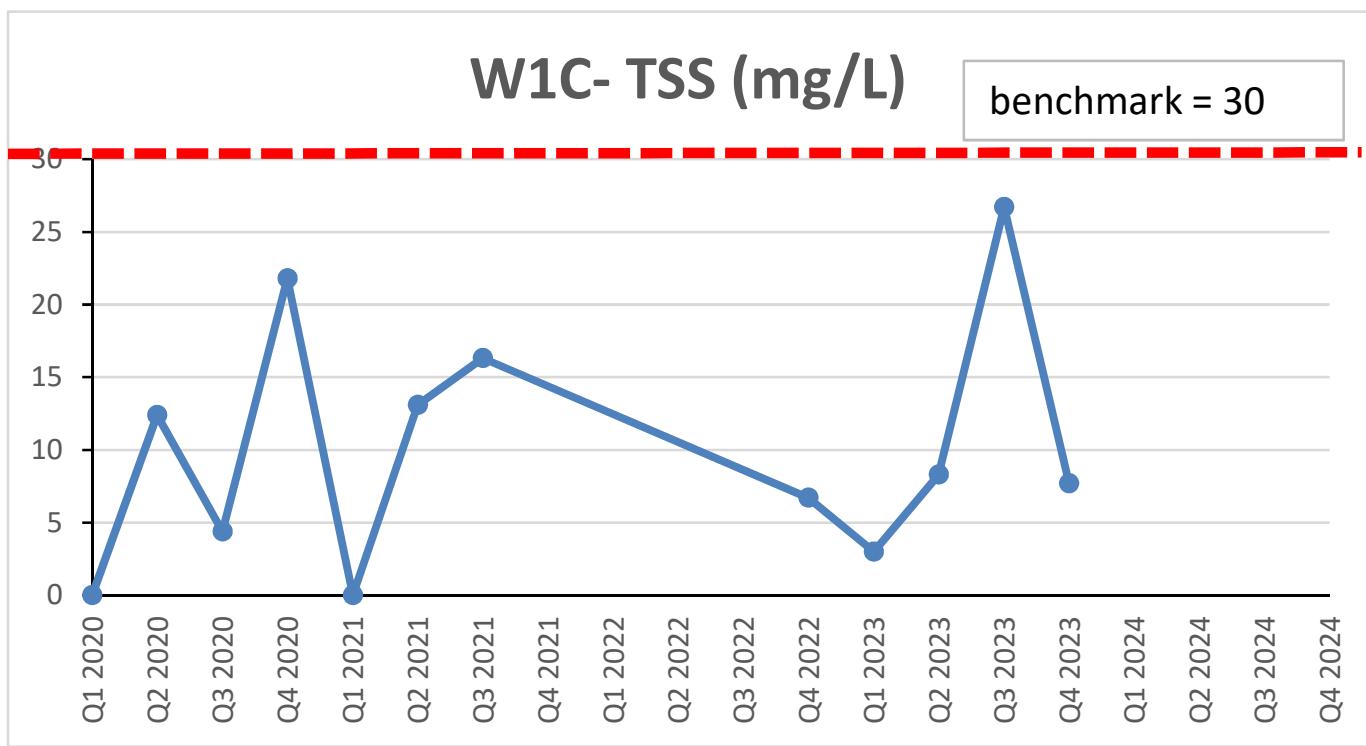
BST Graphs of Long Term Monitoring Results for W1C

W1C = Treated roof runoff from Warehouse 1. Treatment is media filtration unit (MFU).
