## Birch Bay Water Slides Injury Event Investigation Summary February 29, 2024

A serious injury event occurred at Birch Bay Water Slides (BBWS) on August 25, 2023. This report summarizes the Whatcom County Health and Community Services (WCHCS) Department investigation of this event as of February 29, 2024. Our investigation includes information gathered during:

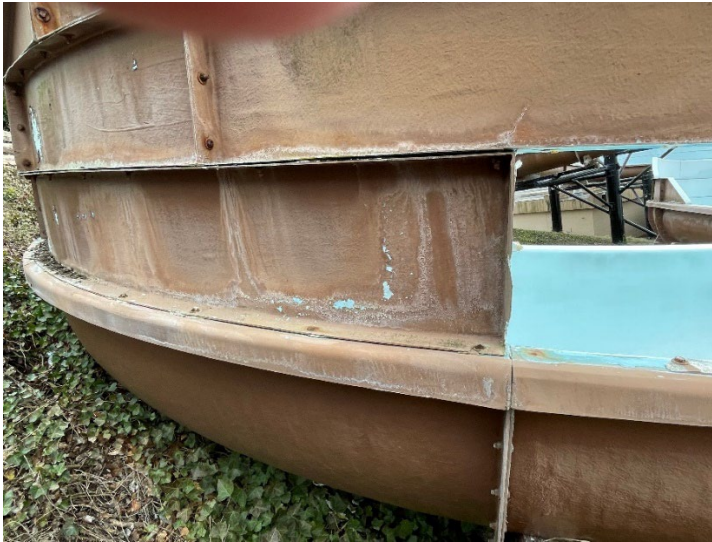
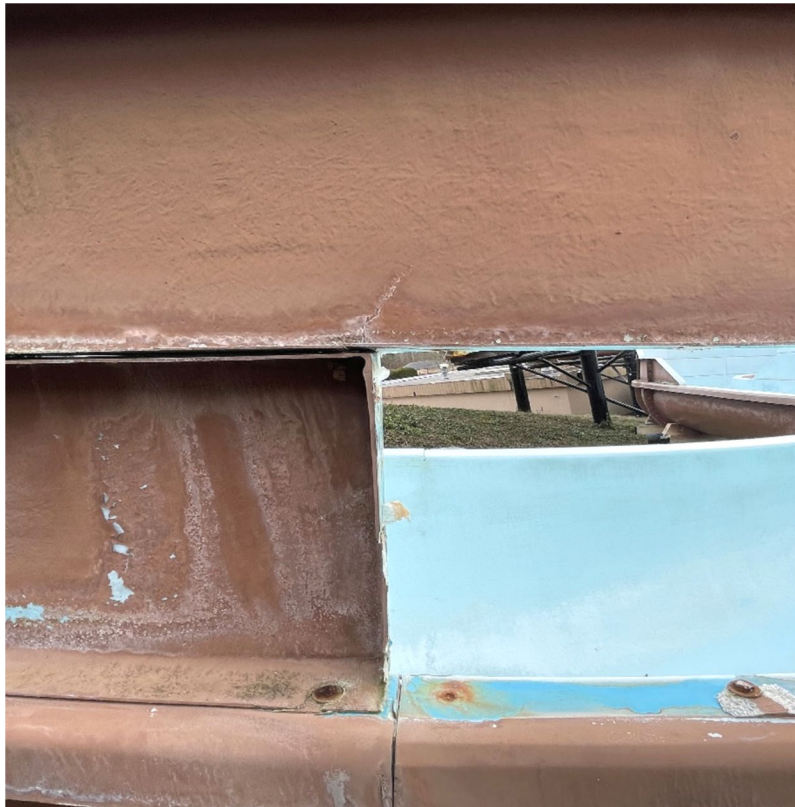
- Corroded fasteners (bolts) where splash guard panels attach to each other and where splash guard panels attach to the slide deck sections.

WCHCS staff are not structural engineers and cannot draw conclusions about the reason the splash guard panel failed, nor can staff draw conclusions based on visual inspections that occurred during the August 29, 2023 and February 2, 2024, site visits. However, these findings indicate a need for a structural integrity assessment of the exterior portions of the slide deck and splash guards in addition to the interior the slide decks, splash guards and support structures by a qualified third party.

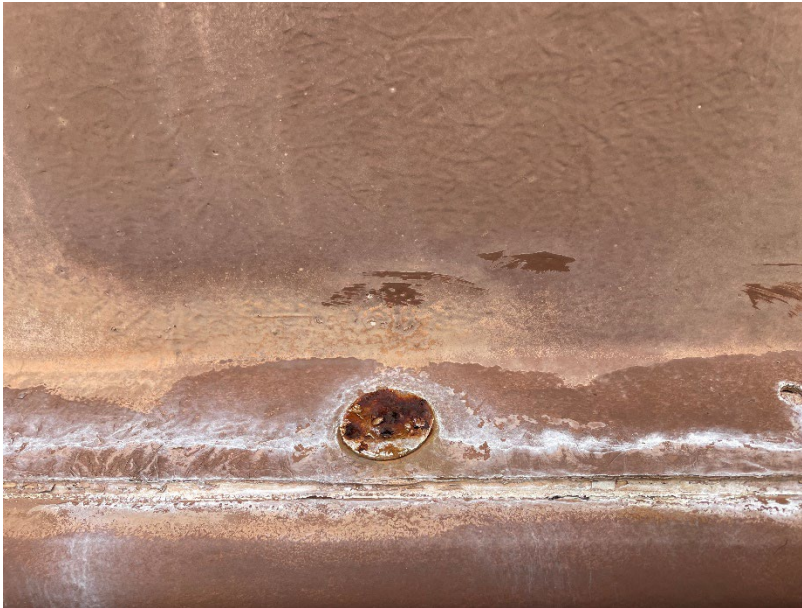
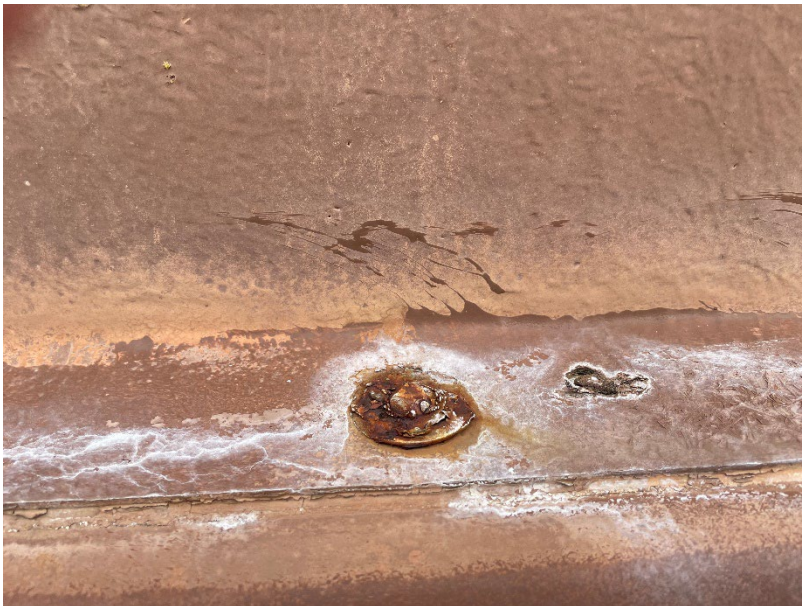
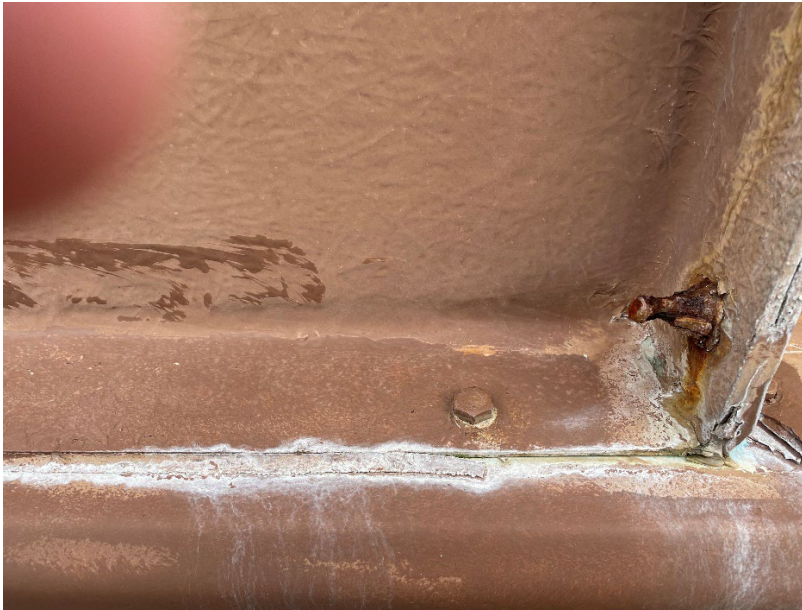
- Corrosion on fasteners and missing fasteners were noted in several locations, including areas where the splash guard failed.

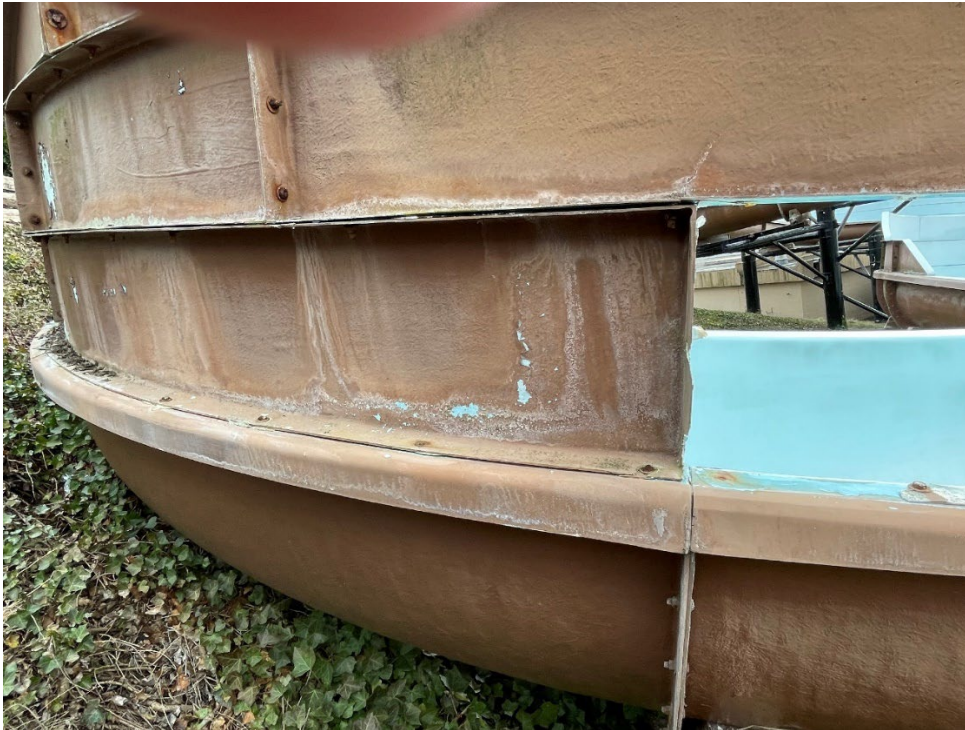
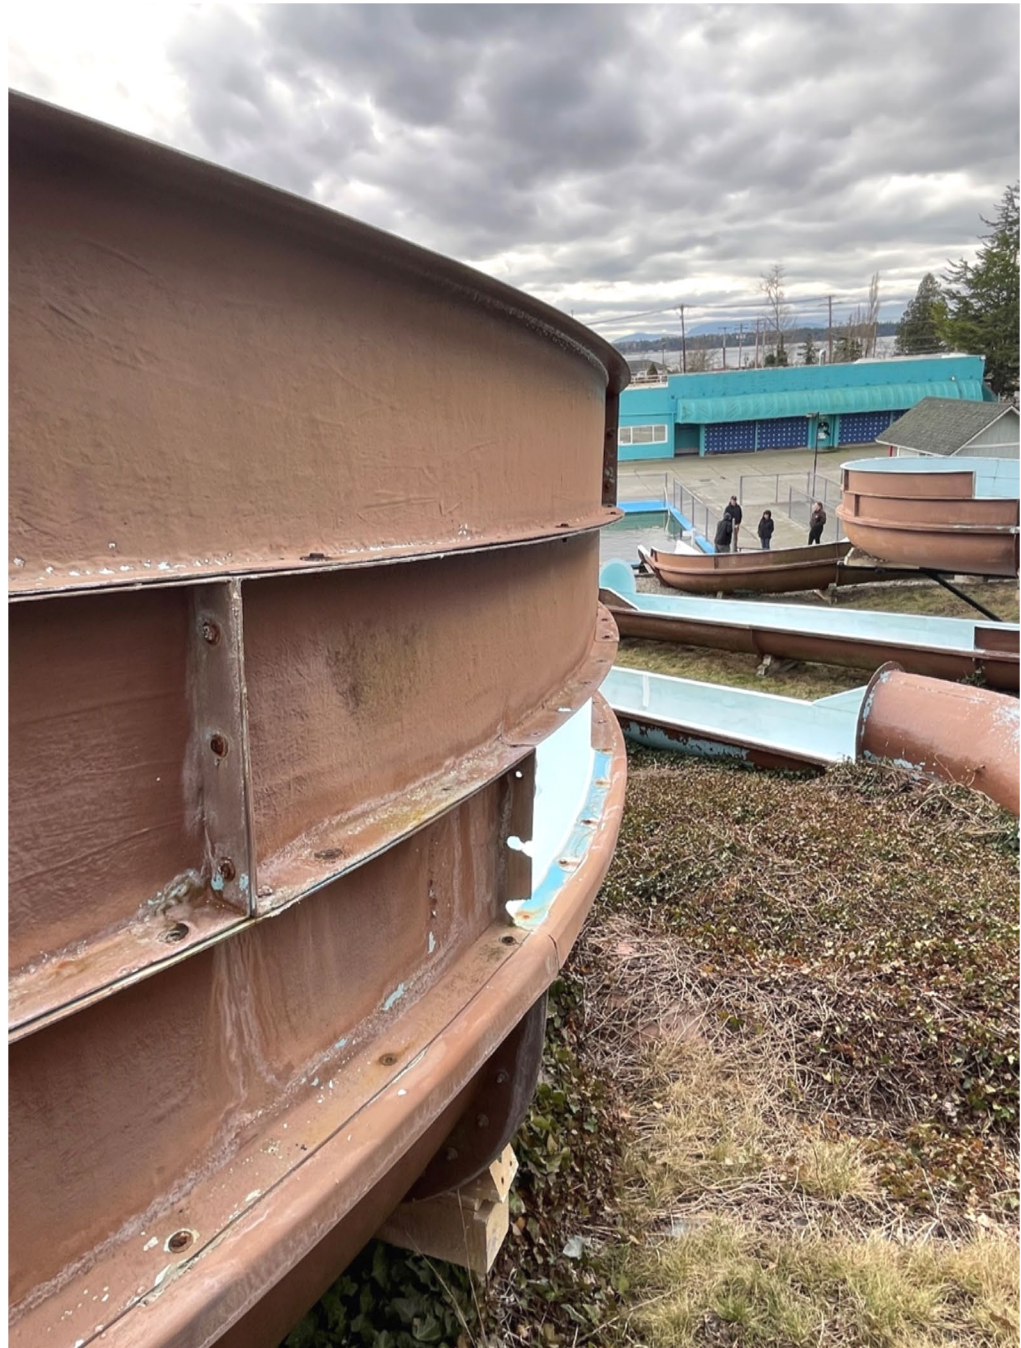
- Missing or damaged fasteners appear more common on the windward (south and west facing) surfaces and less prevalent on other surfaces. The damaged section of the splash guard is on the windward side of the slide.
- Damaged fasteners in area of splash guard failure. A loose splash guard panel is noted just upstream from the failed splash guard panel.

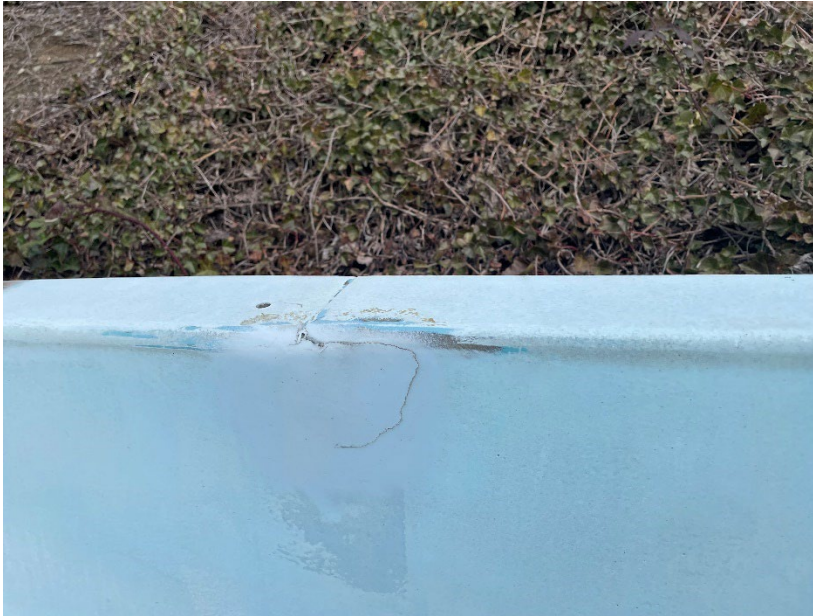
- A crack in a slide deck panel upstream near the failed splash guard panel.

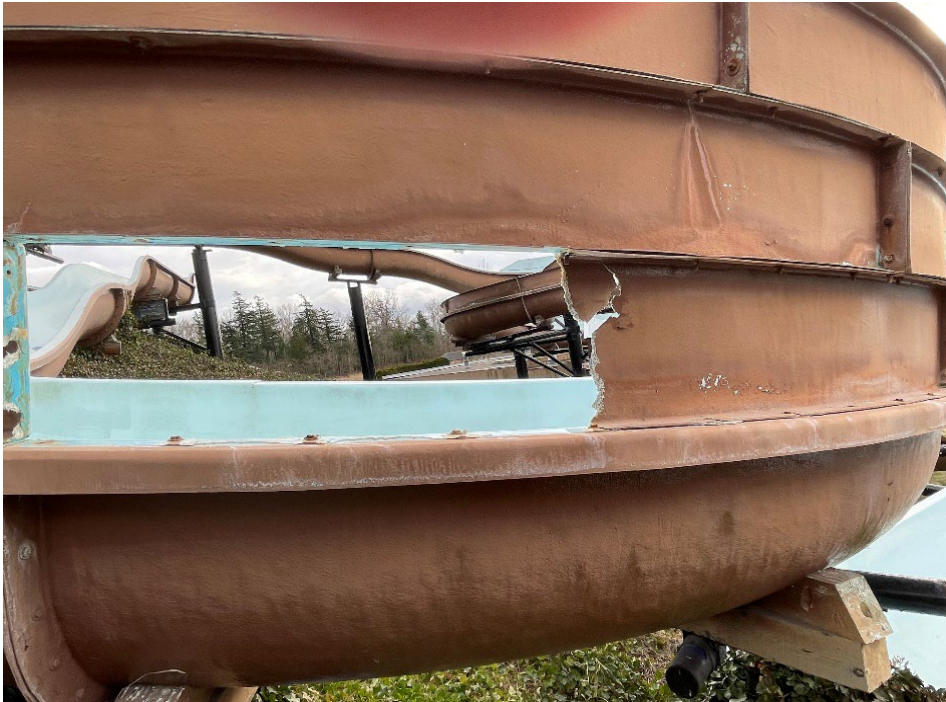
- Downstream end of damaged splash guard. Note crack in panel above on close -up.

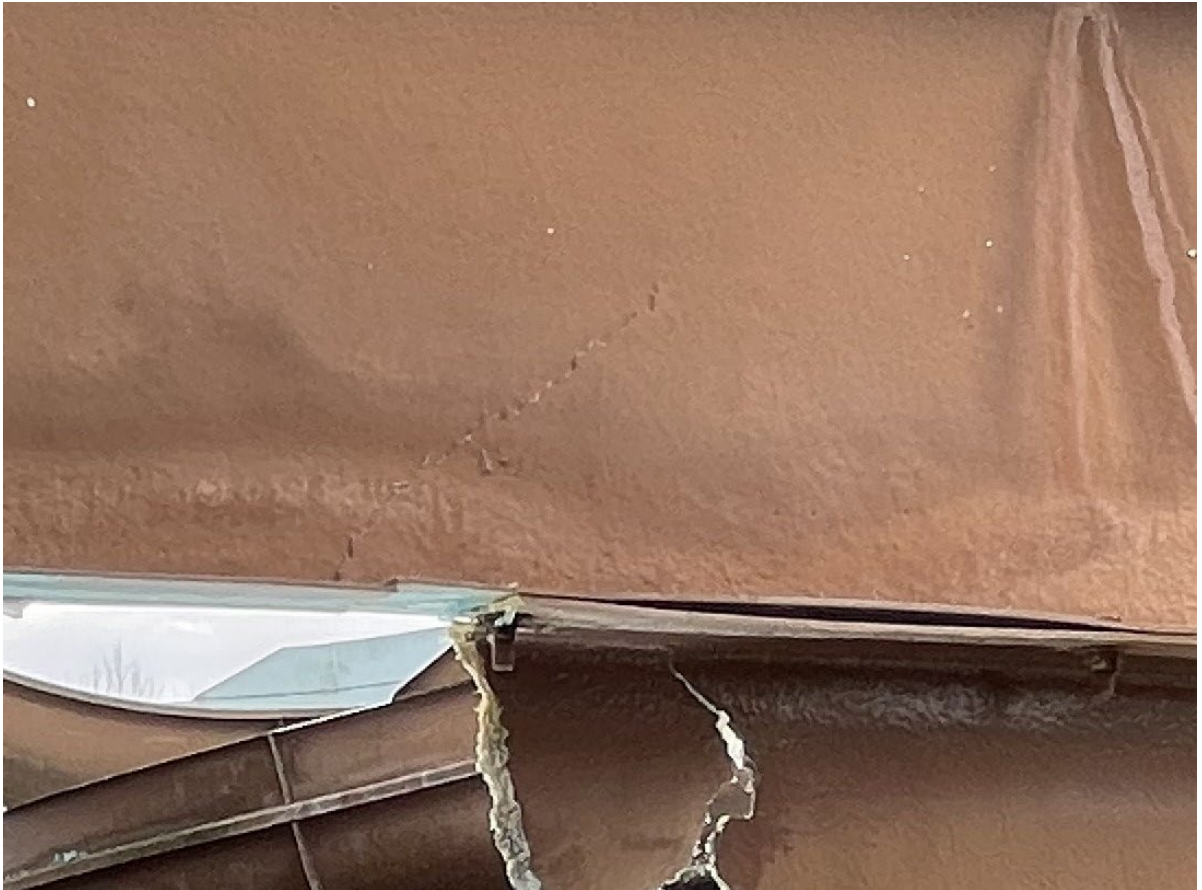
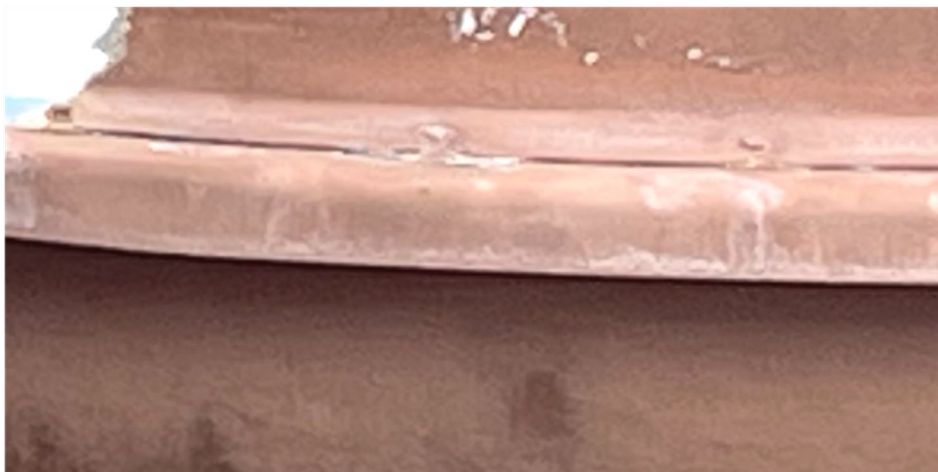
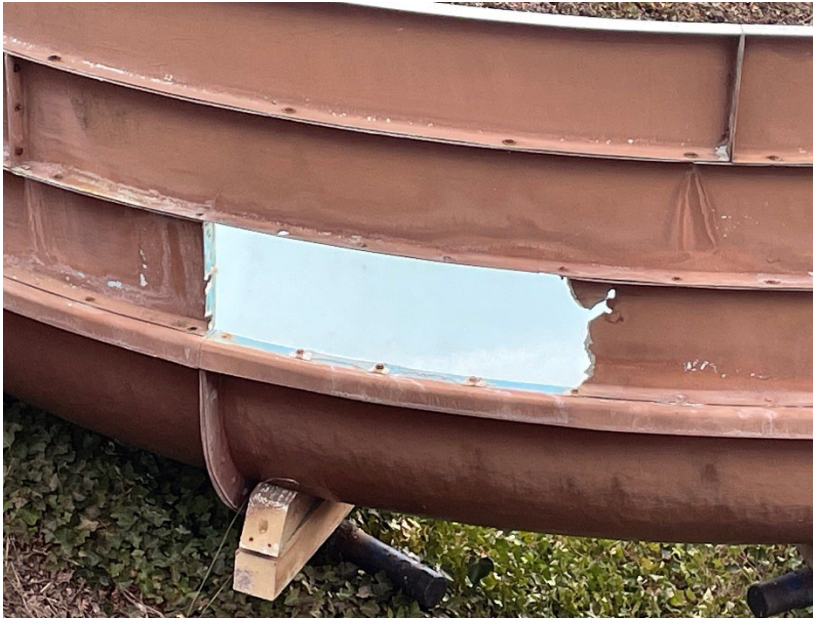
- Previously repaired damage to a splash guard panel immediately downstream from the failed panel is noted. The area around two bolt locations is ripped out and has been patched to provide material for the bolt attachment.
